Baseline report of pre-renovation condition of demonstration cases

Deliverable Report D4.1

Plug-and-Play product and process innovation for Energy-efficient building deep renovation

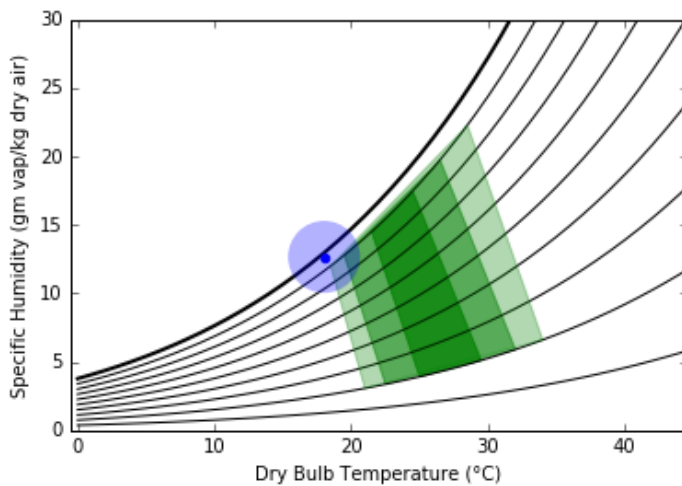
Figure 3: Positioning of the building performance in the comfort zones chart

The average condition (dark blue dot) is located on the upper side of the comfort zones in the psychrometric chart that represents a content of water vapour in the air near to the saturation (relative humidity near to 100%). This aspect in conjunction with the low average air temperature (lower than 18°C) registered, can explain the diffuse mould found in the apartment. The calculation of the percentage of time of building operation within the different Categories is presented in **Error! Reference source not**

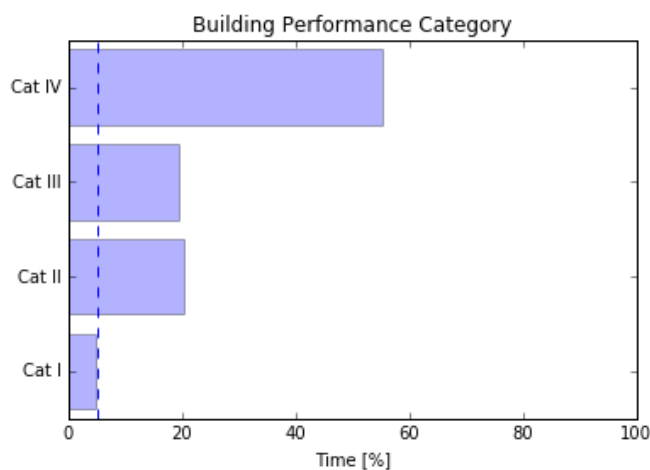
Figure 2: Percentage of operating hours under each building Category according to EN15251 calculated in the demo case of Ancona

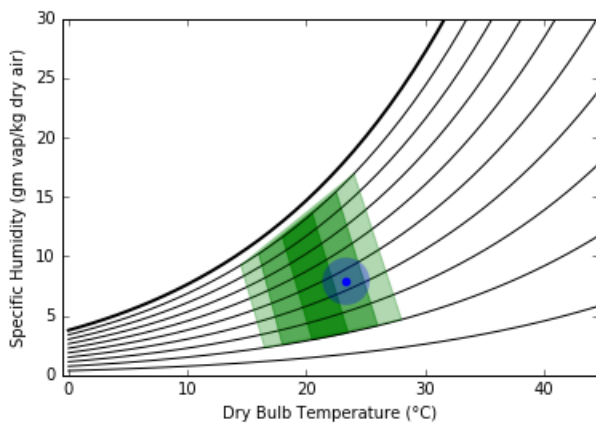
The Predictive model of ISO7730 was applied to calculate the comfort index with a clothing insulation of 0.9 clo and metabolic rate equal to 1.2 met. The monitoring campaign registered an **average PMV of 0.3** with a standard deviation of ± 0.2 . The overall thermal sensation is within the optimal comfort range, slightly unbalanced toward warm sensation. In this case there is a condition of bearable overheating that given the low envelope performance, could lead to high thermal energy consumption. The calculation of the percentage of time of building operation within the different Categories is presented in Figure 5. For about 23% of the time, the building operated a Category III, which indicates a poor condition. The KPI calculated as weighted average of all the monitored rooms turned out to be equal to 0% for Category II and 100% for Category III. The renovation should target the fulfilment of Category II.

Figure 6: Positioning of the building performance in the comfort zones chart

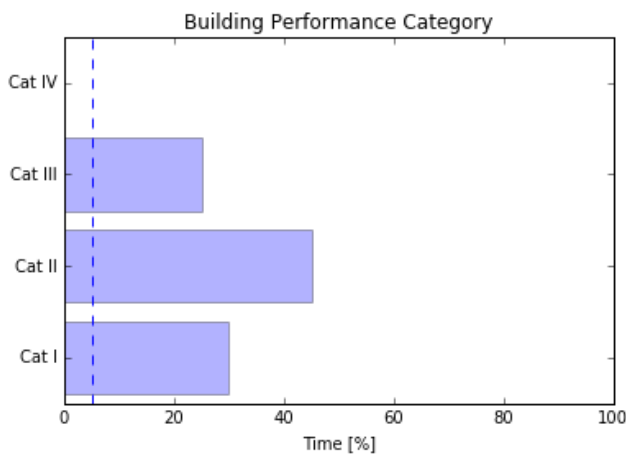
Figure 5: Percentage of operating hours under each building Category according to EN15251 calculated in the demo case of Geneva

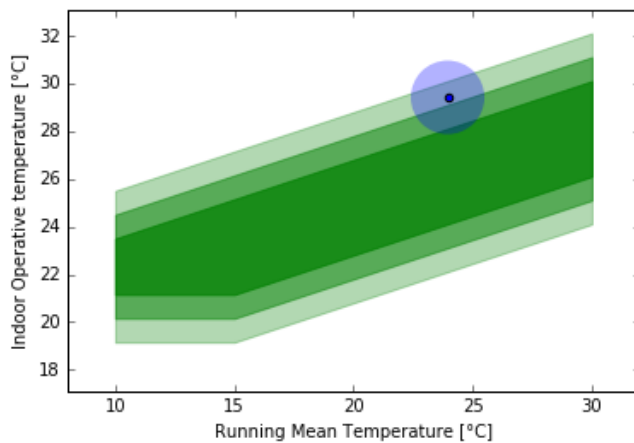
At the same time the environmental data were acquired to assess thermal comfort using adaptive model for naturally ventilated buildings, according to EN15251 standard. Measured data turned out to provide averaged operating conditions in the Category III comfort zone, with a variability that brought the building also outside that category (see Figure 8).

Figure 8: Positioning of the building operation within comfort zones for summer period

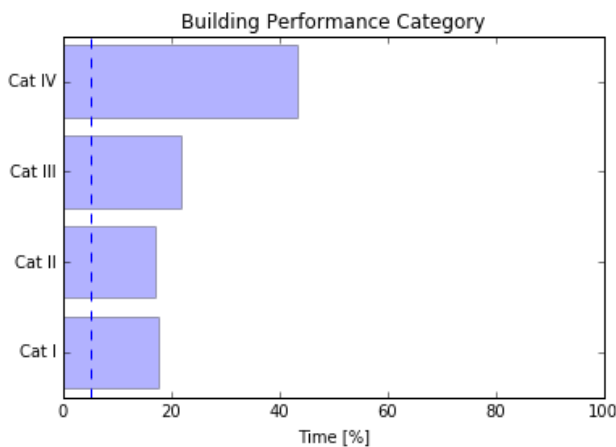
Also, in this case, the percentage of the operating hours inside each Category was evaluated as reported in Figure 9. The building operated for about the 50% of the time as Category IV.

Figure 9: Percentage of operating hours under each building Category according to EN15251 calculated in the demo case of Genova for summer season

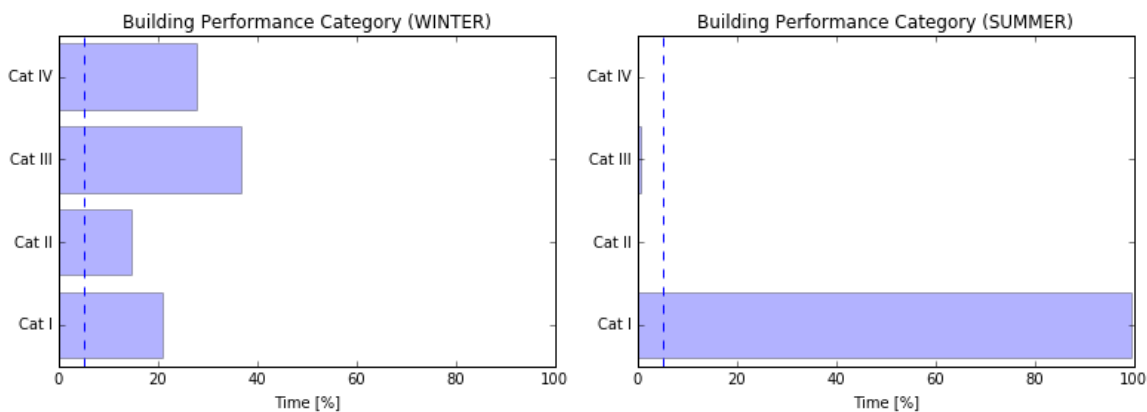
The indoor air quality has been measured and assessed according to the P2ENDURE protocol. One month of CO₂ measurements have been done in both seasons (winter and summer) inside the nursery and spot measurements outside to determine the average external CO₂ level that turned out to be 410 ppm. The data of occupied hours were processed to calculate the KPI.

Figure 10: IAQ - Percentage of operating hours under each building Category according to EN15251 calculated in the demo case of Genova for winter and summer season

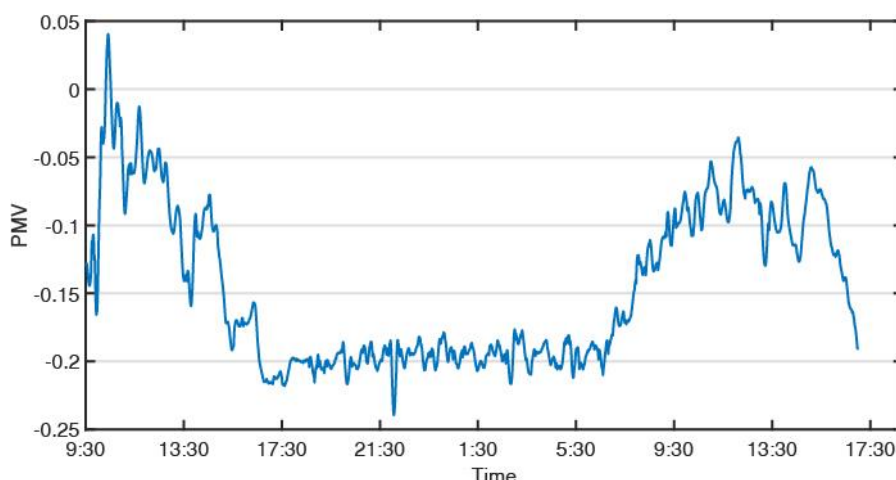
The CO₂ was measured during the two days of testing, but the room was occupied only during the first day.

Figure 12: PMV measured during the two days

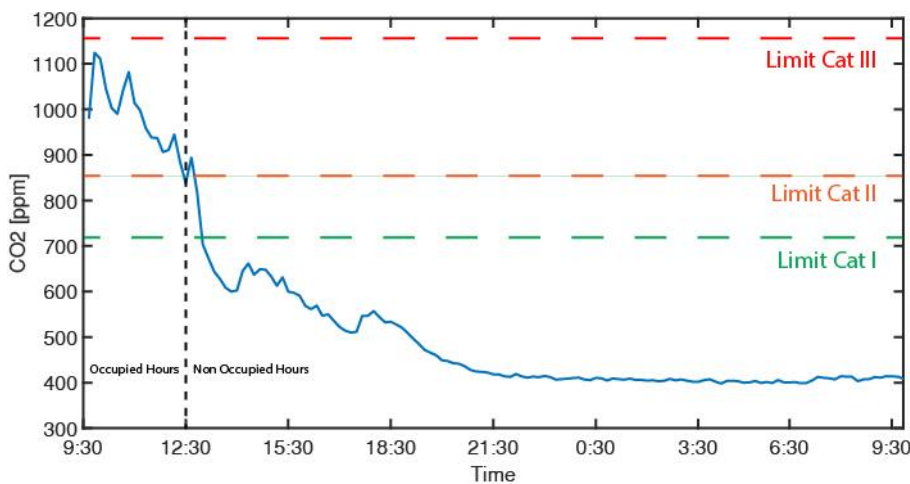
Figure 13 shows the CO₂ trend during the occupied and non-occupied period of the first day. The reference limits for IAQ classification are also provided in the figure. The monitoring turned out to provide a poor level of IAQ during the occupied hours with CO₂ concentrations always within the Category III, leading to a KPI equal to 0%. The improvement of ventilation is highly suggested for the renovation design.

Figure 13: CO₂ measurement during the first day

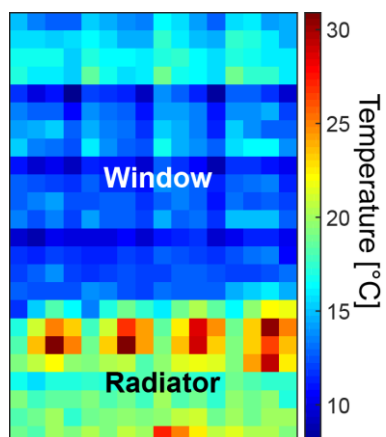
Figure 14 shows an example of thermal map where the main elements composing the outer wall of the room. The window area is distinguished by a lower temperature (average of 10°C) with respect to the other parts. In any case the opaque element of the wall registered an average temperature of about 16°C, providing a strong deviation from the average room air temperature (22.8°C). This deviation, together with the low window temperature, had an impact in terms of radiant temperature. In fact, a mean radiant temperature of 17.8°C was measured near the wall (50cm of distance, not in front of the radiator). This initial investigation suggests a non-efficient building performance since, although thermal comfort is kept within requirements, the air temperature is kept high to balance the cooling effect of the building envelope. An improved insulation of both windows and walls could reduce this effect to permit a lower air temperature without reducing thermal comfort, but also improving the building energy efficiency.

Figure 14: Low-resolution thermal image of the wall exposed to external environment
